SETTLEMENT AGREEMENT

DOUGLAS COUNTY, NEVADA,
a political subdivision of the State of Nevada,
the STATE OF NEVADA, ex. rel., its Division of State
Parks, and PARK CATTLE CO. , successor-in-interest to
DANGBERG HOLDINGS NEVADA, LLC, a Nevada
limited liability company

EFFECTIVE AS OF DECEMBER 27, 2002

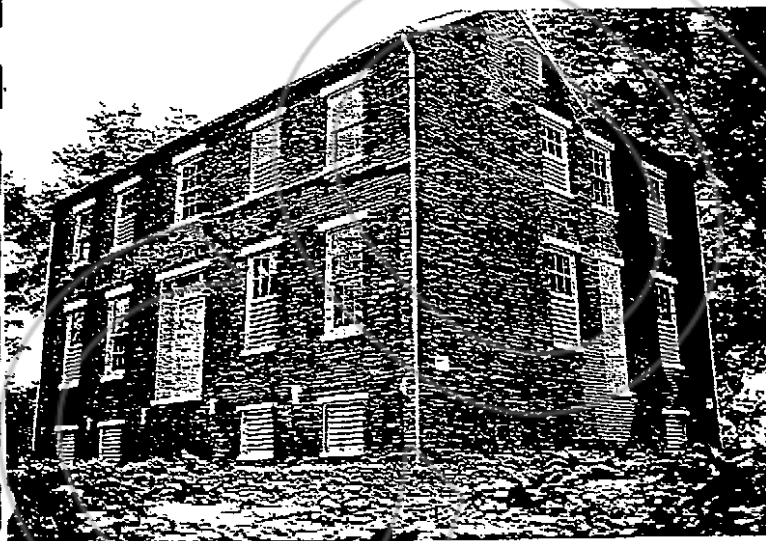
Figure 1. Proper mothballing treatment: This building has been successfully mothballed for 10 years because the roof and walls were repaired and structurally stabilized, ventilation towers were added, and the property is maintained. Photo: Charles E. Fisher, NPS.

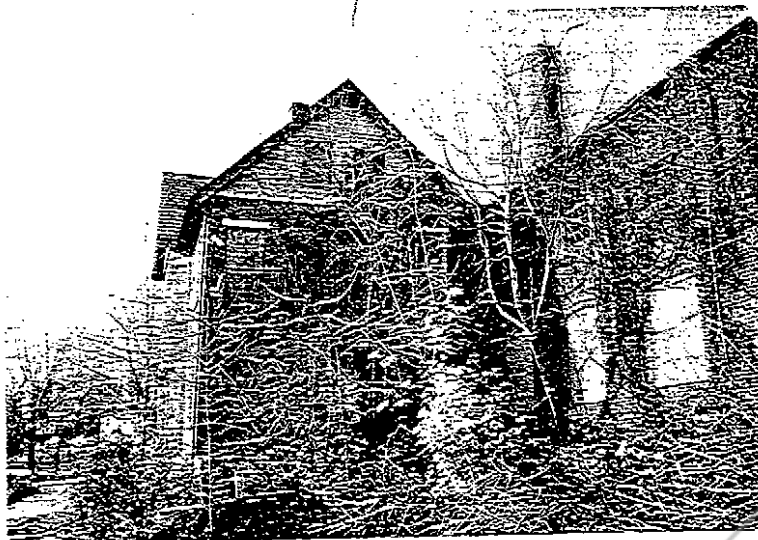
Figure 2. Improper treatment: Boarding up without adequate ventilation, lack of maintenance, and neglect of this property have accelerated deterioration. Photo: NPS file.

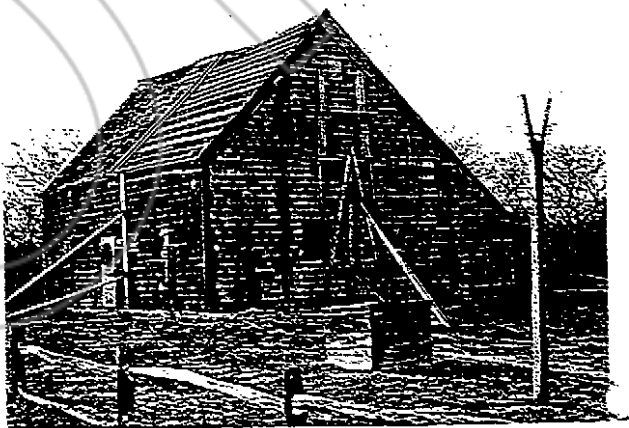
Figure 3. Buildings seriously damaged by storms or deterioration may need to be braced before architectural evaluations can be made. Jehro Coffin House. Photo: John Milner Architects.

to be structurally unsound until the condition of the structure can be fully assessed (see fig. 3). If pigeon or bat droppings, friable asbestos or other health hazards are present, precautions must be taken to wear the appropriate safety equipment when first inspecting the building. Consideration should be given to hiring a firm specializing in hazardous waste removal if these highly toxic elements are found in the building.

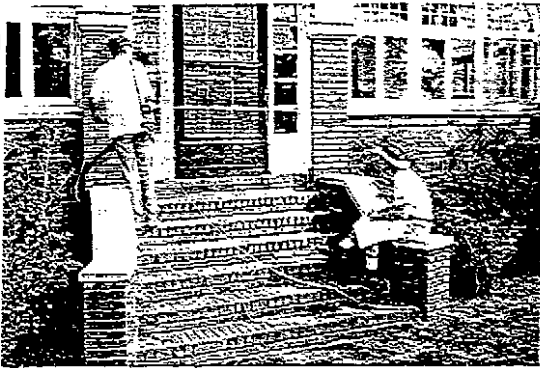
Figure 4. Documenting the building's history, preparing schematic plans, and assessing the condition of the building will provide necessary information on which to set priorities for stabilization and repair prior to securing the building. Photo: Frederick Lindstrom, HAAS.

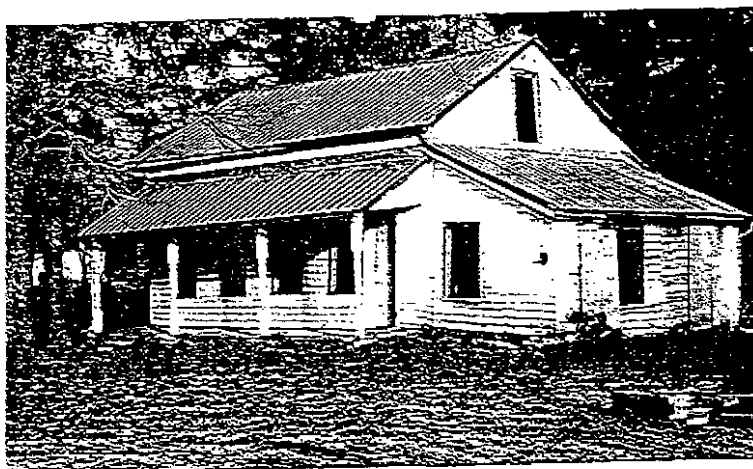
Figure 7. Non-historic materials are appropriate for mothballing projects when they are used to protect historic evidence remaining for future preservation. This lightweight aluminum channel frame and roofing covers the historic wooden shingle roof. Galvanized mesh panels secure the window openings from intrusion by raccoons and other unwanted guests. Photo: Williamsport Preservation Training Center, NPS.

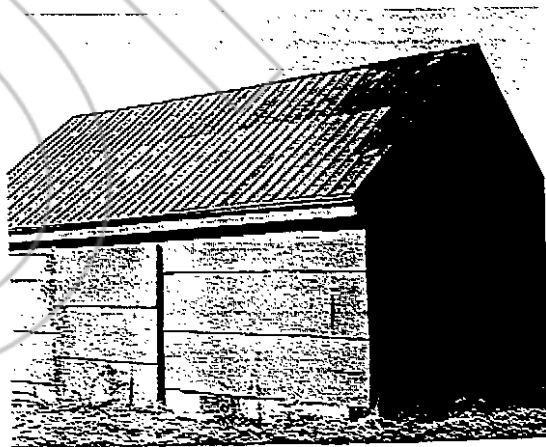
Figure 9. Severely deteriorated wooden siding on a farm building has been covered over with painted plywood panels as a temporary measure to eliminate moisture penetration to the interior. Foundation vents and loose

patterns or by installing panels over a frame of battens (see fig. 9). Generally, however, it is better to repair deteriorated features than to cover them over.

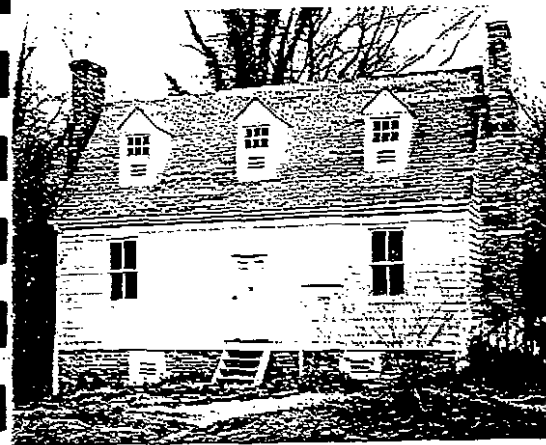
Figure 10. Regrading around the Booker Tenement at Colonial Williamsburg has protected the masonry foundation wall from excessive damp. This building has been successfully mothballed for over 10 years. Note the attic and basement vents, the temporary stairs, and the informative sign interpreting the history of this building.

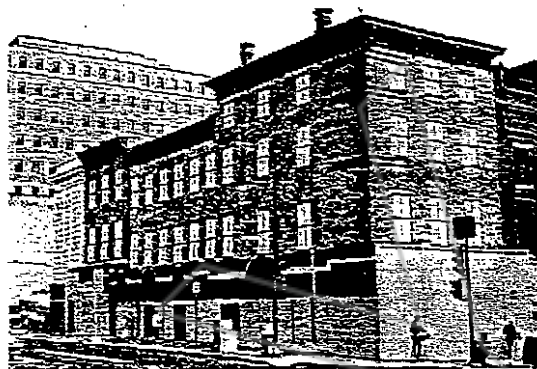
Figure 11. Urban buildings often need additional protection from unwanted entry and graffiti. This commercial building uses painted plywood panels to cover expansive glass storefronts and chain link fencing is applied on top of the panels. The upper windows on the street sides have been covered and painted to resemble 19th century sash. Photo: Thomas Jester, NPS.

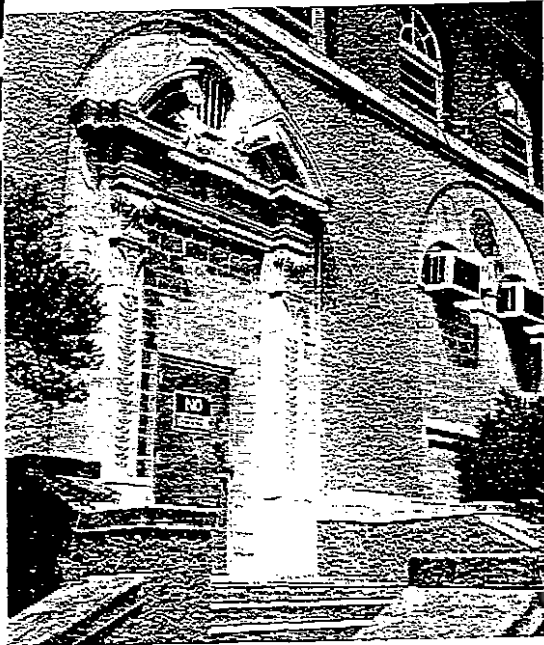
Figure 12. First floor openings have been filled with cinderblocks and doors, window sash and frames have been removed for safe keeping. Note the security light over the windows and the use of a security metal door with heavy duty locks. Photo: H. Ward Jandl, NPS.

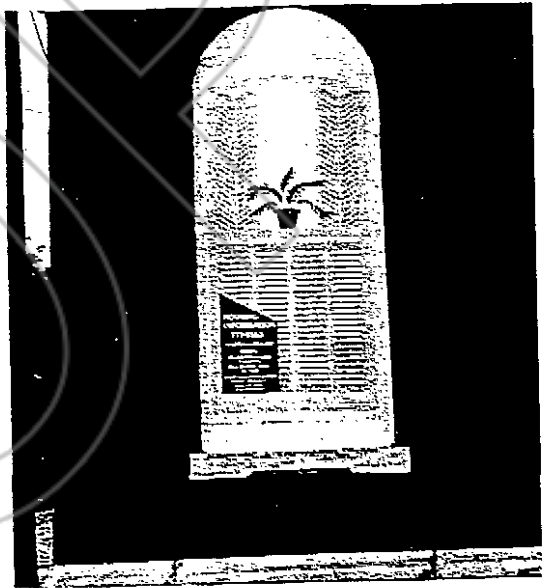
Figure 15. Painting trompe l'oeil scenes on plywood panels is a neighborhood friendly device. In addition, the small sign at the bottom left corner gives information for contacting the organization responsible for the care of the mothballed building. Photo: Lee H. Nelson, EALA.

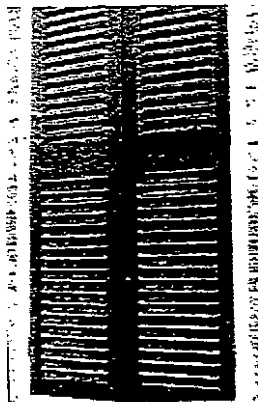
Figure 16. Historic louvered shutters make excellent security closures with passive ventilation.

If the building has shutters, simply close the shutters and secure them from the interior (see fig. 16). If the building had shutters historically, but they are missing, it may be appropriate to install new shutters, even in a modern material, and secure them in the closed position. Louvered shutters will help with interior ventilation if the sash are propped open behind the shutters.

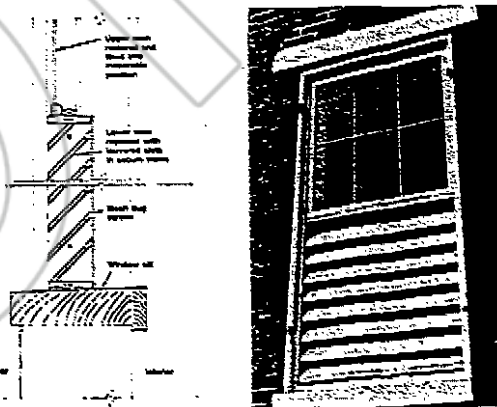
Figure 18. Heavy duty wooden slatted louvers were custom fabricated to replace the deteriorated lower sash. The upper sash were rebuilt to retain the historic appearance and to allow light into this vacant historic building. Refer back to Fig. 1 for a view of the building. Photo: Charles E. Fisher, NPS. Drawing by Thomas Vitarca.

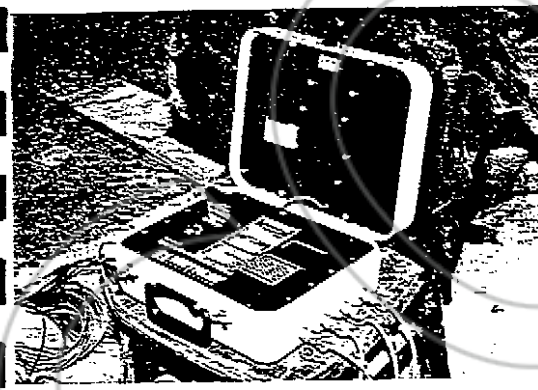
Figure 20. Portable monitors used to record temperature and humidity conditions in historic buildings during mothballing can help identify ventilation needs. This data can be downloaded directly into a laptop computer on site. These monitors are especially helpful over the long term for buildings with significant historic interiors or which are remaining furnished. If interiors are remaining damp or humid, additional ventilation should be added or the source of moisture controlled.

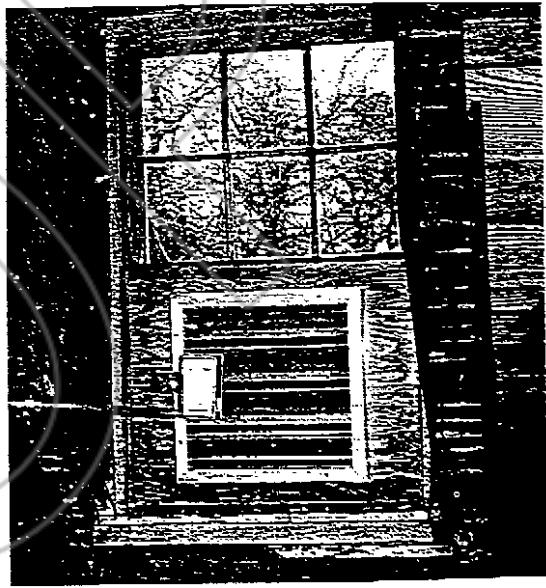
Figure 21. This electric thermostat/humidistat mounted in the attic vent controls a modified ducted air fan system. The unit uses temporary exposed sheet metal ducts to pull air through the building and exhaust it out of the basement. For over ten years this fan system in combination with 18" x 18" preformed louvers in selective windows has kept the interior dry and with good air exchanges.

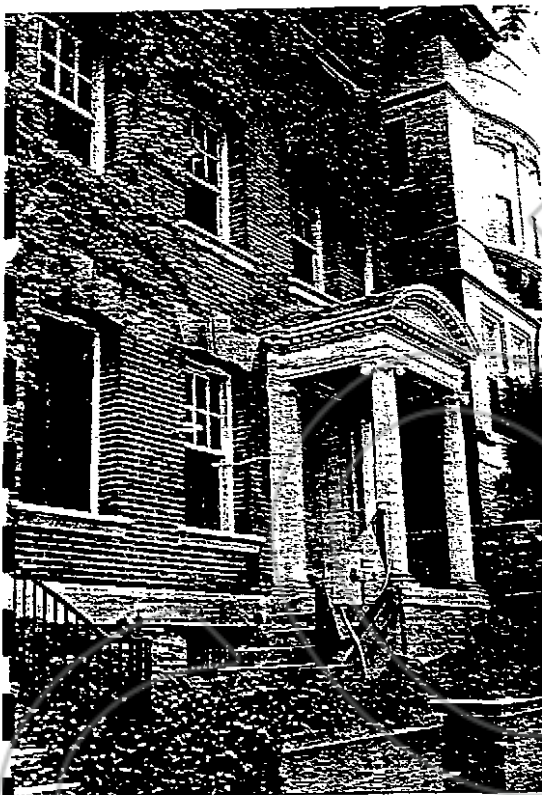
Figure 22. All systems except temporary electric have been shut off at this residence which has been mothballed over 20 years. An electric meter and 100 amp panel box have been set on a plywood panel at the front of the building. It is used for interior lighting and various alarm systems. The building, however, is showing signs of moisture problems with efflorescent stains on the masonry indicating the need for gutter maintenance and additional ventilation for the interior. The vegetation on the walls, although picturesque, traps moisture and is damaging to the masonry. Photo: H. Ward Jarrell, NPS.

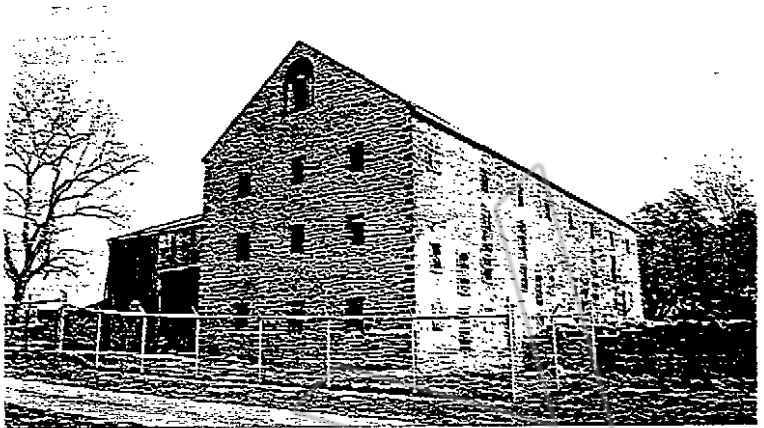
Figure 24. Once mothballed, a property must still be monitored and maintained. The openings in this historic barn has been modified with a combination of wood louvers and metal mesh panels which require little maintenance. The grounds are regularly mowed, even inside the chain link security fence. Photo: Williamsport Preservation Training Center, NPS.

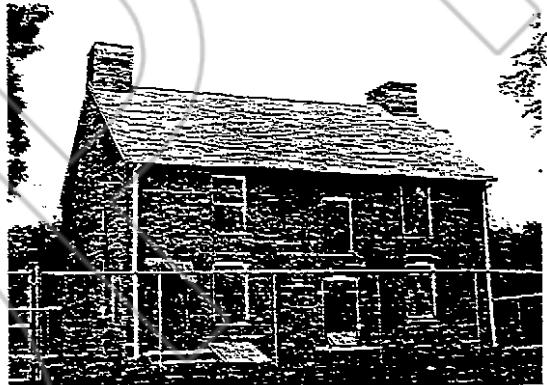
Figure 25. Above is a summary of the tasks that were necessary in order to protect this significant property while restoration funds are raised. Photographs: Michael Mills; Ford Farewell Mills Gatsch Architects.

a. A view showing the exterior of the house in its mothballed condition.

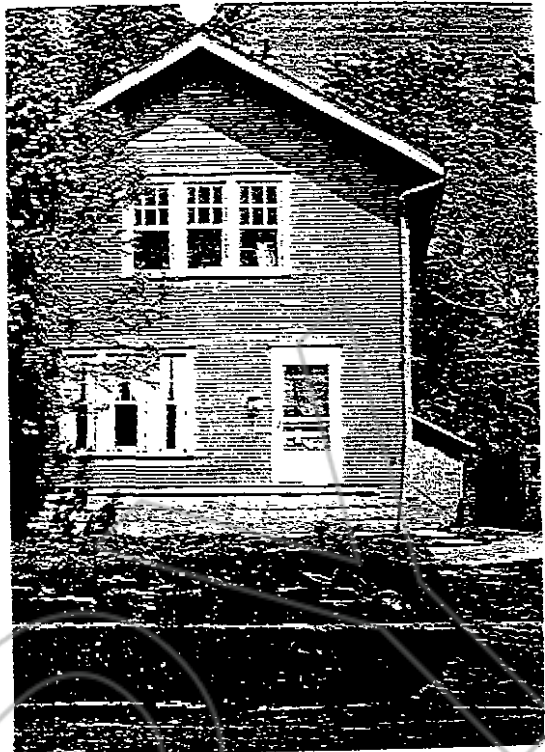
Figure 27. This residential building blends into its neighborhood even though all the windows have been covered over and the front steps are missing. The grounds are maintained and the special attention to decoratively painting the window panels shows that the property is being well cared for until it can be rehabilitated. Photo: Ohio Historical Society.
